CERAMIC HIGH PRESSURE GAS PATH SEAL

G. C. Liotta GE Aircraft Engines 1000 Western Avenue Lynn, MA 01910

August 1987

Final Report for Period January 1982 to April 1987 Contract Number NAS3-23174

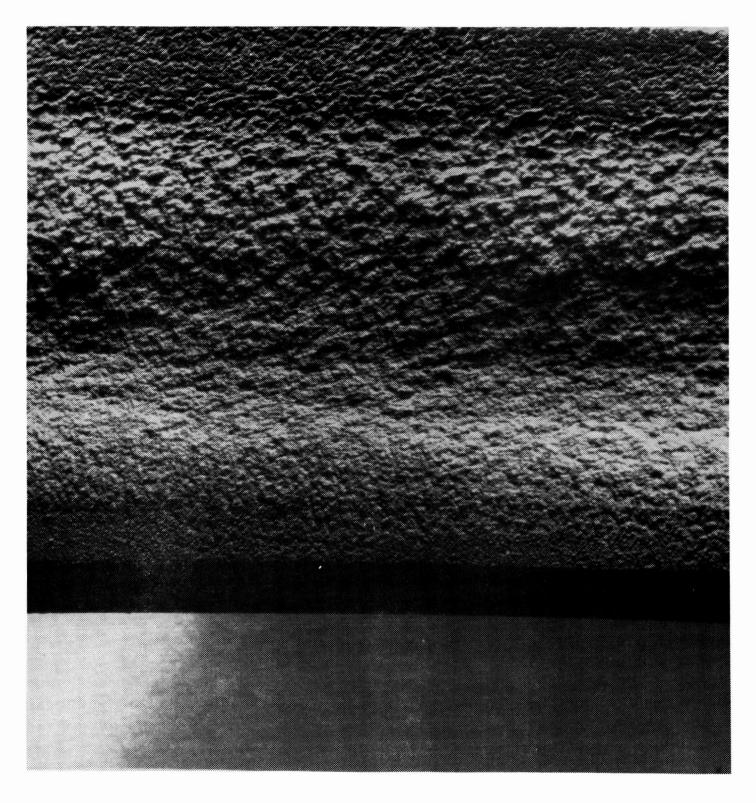
The Stage 1 ceramic shrouds eroded more than the Bradelloy or solid shrouds, as shown in Figures 4-34 through 4-37, but did not erode through the ceramic coating. The average erosion depth of the Bradelloy shroud was negligible. The solid shroud eroded away about 9 mils average. The ceramic shroud eroded away about 21 mils average. The erosion path was mainly directly above the tip of the Stage 1 turbine blades. Erosion was considerably less above the trailing edge of the Stage 1 turbine blades where maintaining clearances is most critical. The ceramic shrouds are acceptable for continued engine operation.

Figure 4-35. Engine 207018-8A Closeup of Erosion of Ceramic.
